**REPORT TO COUNSEL
CONCERNING
INJURY TO AMANDA ARNOLD**

Project No. 3565

2 February 2018

**Charles R. Cushing, Ph.D., P.E.
C. R. Cushing & Co., Inc.
30 Vesey Street
New York, NY 10007**

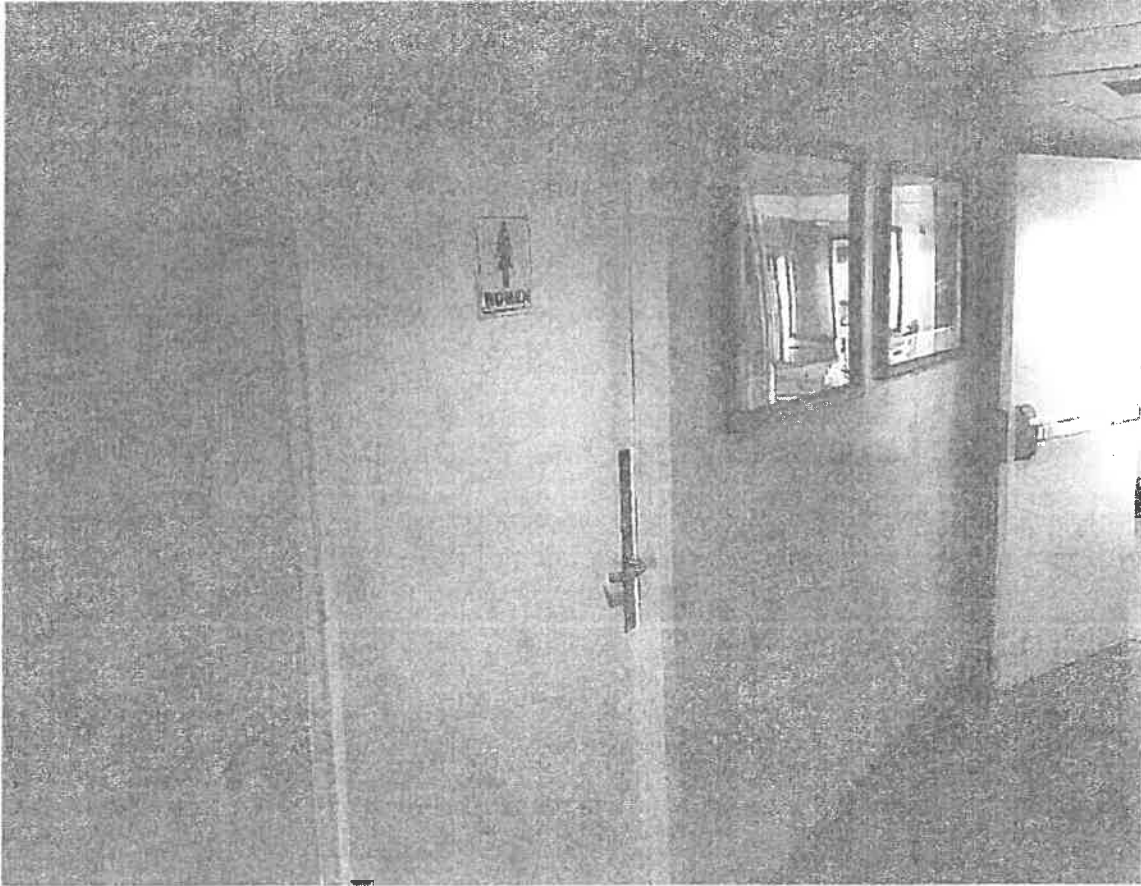
Opposite the door, five feet across the passageway was a fore-and-aft, horizontal pipe handrail affixed to the starboard passageway bulkhead. However, along the passageway bulkhead where the door opening to the women's public restroom was fitted, there was no handrail.

Fig. 1 – Entrance to Women's Public Restroom, Looking to Port and Forward. Note Absence of Handrail.

U.S.C.G. regulations require handrails on both sides of interior corridors that are 72 inches or wider. The centerline corridor, outside the women's restroom on the EAGLE, is 60 inches wide and while there is a handrail on the bulkhead outside the men's restroom, unfortunately there was none outside the women's restroom (see photos).

4. A major contributing cause for the plaintiff's casualty was the absence of handrails on the port side of the passageway. Handrails on one side of a passageway means that when persons are exiting a door and moving athwartships and must turn ninety degrees to move fore-and-aft, and at the same time the vessel is rolling, railings are needed on both sides of the passageway for passengers to stabilize themselves.

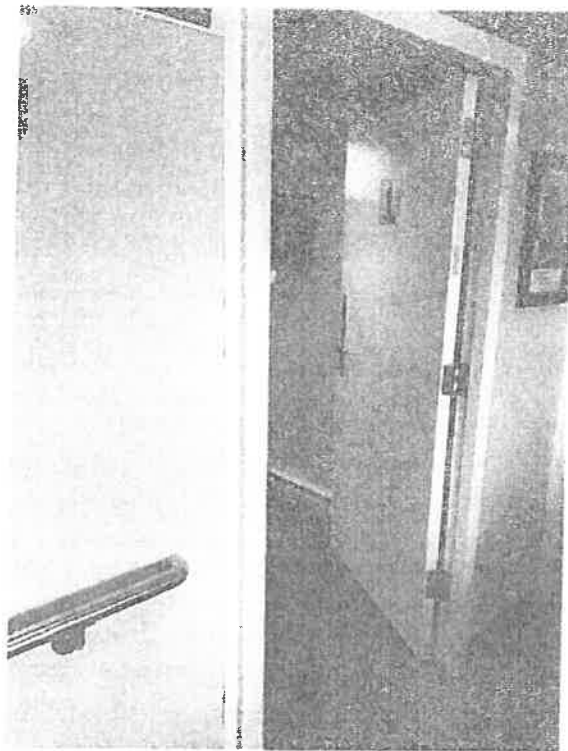
Fig. 2 – Entrance to Men's Public Restroom. Note Handrail.

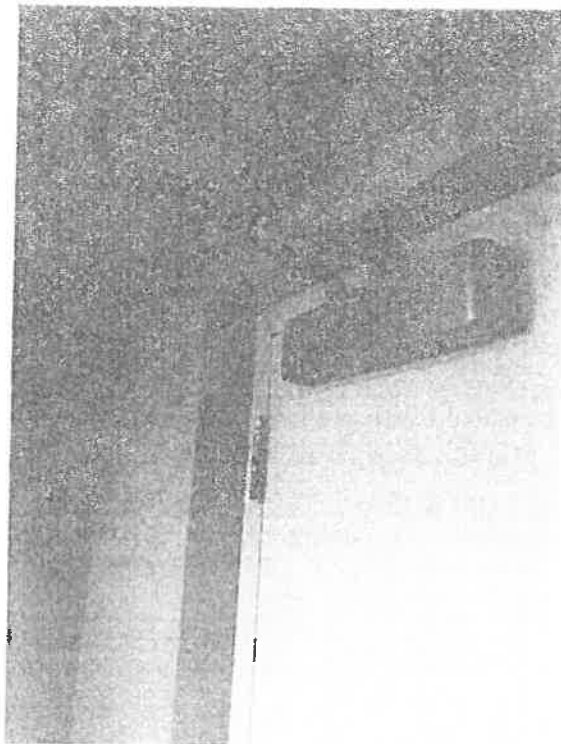
Fig. 3 – DORMA Door Closer.

The closer has adjustable spring power and backcheck positioning adjustment. The adjustable backcheck takes effect when approximately 70° closed. The closer has adjustable hydraulic values to control latch closing speeds, which is to assure an effective ANSI backcheck range.

force of 126 lbs. The door closed from its fully open position to its closed position in 1.5 to 2.0 seconds. The door closer was clearly not functioning or seriously out of adjustment. In effect, the door was slamming closed. At the handle edge of the door, the door was striking the jamb with a force in excess of 120 lbs.

The door failed to meet standards for two reasons. First, the closer did not retard the motion of the door. Second, with the 190-lb. door slamming closed, the force on the jamb was order of 120 lbs. Therefore, the door would require more than 5 to 15 lb. force to open it against the closing force. Further, the test on the door carried out on 29 December 2016 occurred at the dock, in calm water. If the EAGLE had been in a seaway in blustery weather and rolling such as on 30 September 2016, rather than at the dock, the unrestrained door would have slammed even faster and with greater force.
